Seepage Tank Stabilization Sinkhole due to Soil Subsidence

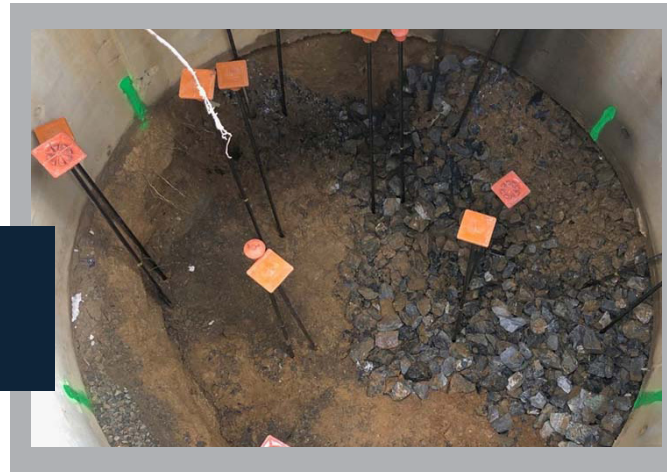
In New Holland, PA, heavy rainfall had caused a sinkhole underneath a stormwater management infiltration structure. The sinkhole caused a loss of 3 feet of soil below the structure, soil loss around an adjacent driveway, and a storm drain to settle. Utility Services Group, Inc (USG), an underground infrastructure contractor out of Camp Hill, PA, was contacted to help remediate the sinkhole.

After a site visit, USG decided the best repair solution was to stabilize the sinkhole feature with the NCFI Terrathane 24-003 geotechnical polyurethane system. The process worked by injecting the 24-003 below the structure at depths of -4ft and -7ft immediately below and around the system.

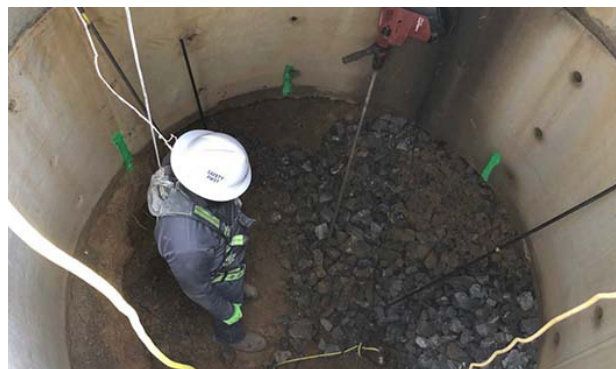
After the karst feature was stabilized, USG replaced the lost soil with a 4” to 6” riprap up to the original bottom of the structure. A nearby conduit alongside the tank had also experienced loss of support and USG used fill stone and polyurethane injection to stabilize this area.

Due to the soil loss, the adjacent storm drain had experienced settlement of approximately 2” and joint separation. USG stabilized the soil around the storm drain and sealed the joints with the 24-003.
