Port of Seattle Seawall Stormwater I/I Repair

24-042 CASE STUDY

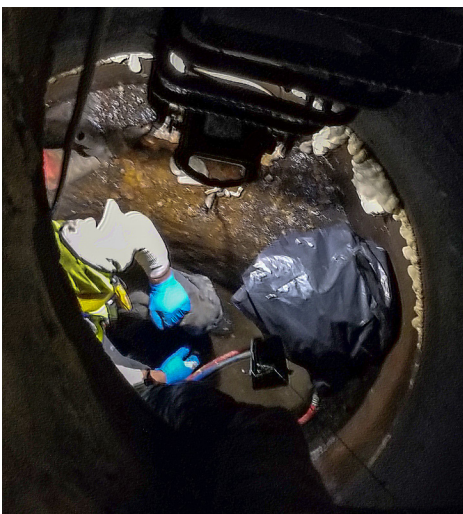
The contractor, SlabJack Geotechnical, approached the project using the TerraThane 24-003 to fill the voids around the outfalls and pipes, seal the joints, and stabilize and densify the support soils. With access restrictions due to the pipe diameter, SlabJack injected the polyurethane laterally down the length of the pipe at the 2 and 10 o'clock positions from the seawall outfall and from access manholes. The injection rods were inserted lengthwise down the pipe and cut to varying lengths to provide injection zones at every 5ft.

In areas where soil densification was required, this was especially important at the pipe bellies, SlabJack Geotechnical inserted rods at angled positions to create a multiple depth injection to effectively rehabilitate the soils against future settlement.

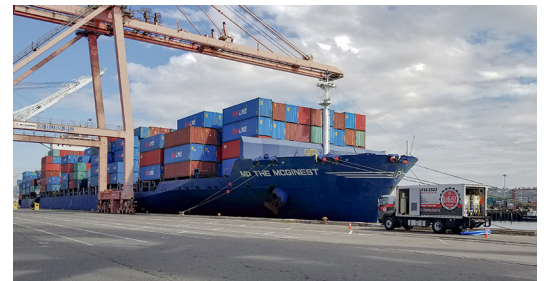
used 12,250 lbs of 24-003 to complete the project. They ensured the project's success with pre and post CCTV inspections and removed any polyurethane tailings and screened all material from entering the ecosystem.
