Neshoba Spillway Rehabilitation

24-003 Void Fill and Stabilization

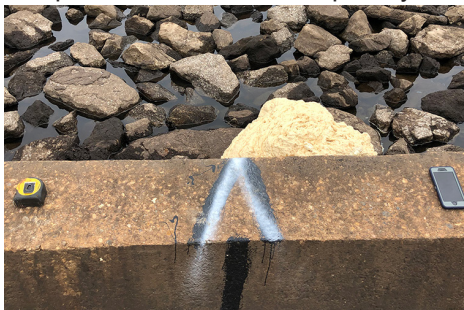
In Neshoba County, MS, the Mississippi Department of Wildlife, Fisheries, and Parks (MDWFP) was noticing some severe undermining in the Neshoba County Lake Spillway. The Lake manager noticed two swirling patterns on the lake-side of the dam and two additional swirling patterns on the spillway side in a detention area which was used to equalize flow rates. The dam was also showing signs of cracking and settlement on the top slabs. The Lake Manager was concerned that water was getting below the cap and causing soil subsidence and could compromise the dam and spillway.

To repair the seepage, MDWFP contracted with Bulldog Construction (through a solicited-bid contract) to inject the TerraThane 24-003 high-density polyurethane into the weak soil zones to fill the voids, stabilize the soils, and stop the water seepage through the dam and the spillway.

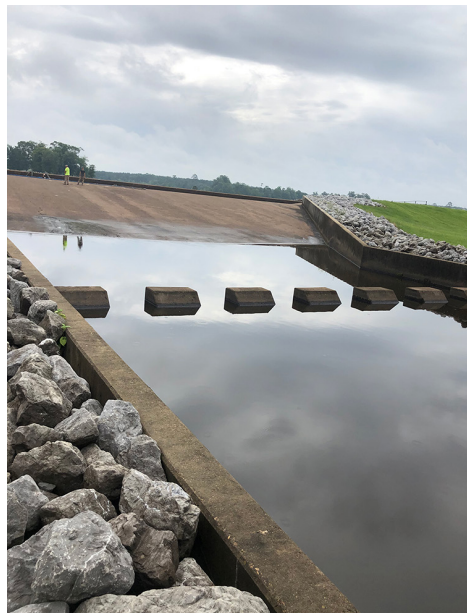
To repair the dam and spillway, Bulldog Construction had to address the dam-side first. Bulldog approached this by 175' x 160' area-wide area using Deep Soil Injection to stabilize the soils and re-establish contact with the dam. Bulldog Construction used a 1', 4' and 8' deep injection pattern on 4' x 4' gridded area. The goal was to saturate the zone with the 24-003, densifying the soils, sealing the dam, and displacing any present water.

Prior to the injection phase, Bulldog pre-drilled injection/chase holes down the spillway. As the injections were made, the initial focus was near the knee wall on the dam-side. As injections progressed toward the spillway, Bulldog followed the water as it seeped through the chase holes and continued the injections down the spillway until the water extrusion stopped.

The project took 3 days with about 40 cubic yards of material (approximately 4,000 lbs of 24-003.) Bulldog Construction sealed the diverters, undersealed the slabs, and stabilized the soils at depth. The cap was treated and the water seepage was stopped.
